Manhole Inspection Summary

Manhole # S43C__005MH

Insp Date: **4/13/08 9:55 AM**

Location Address: **Bond**

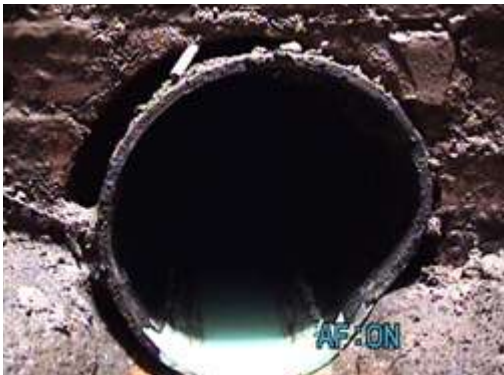
house connection

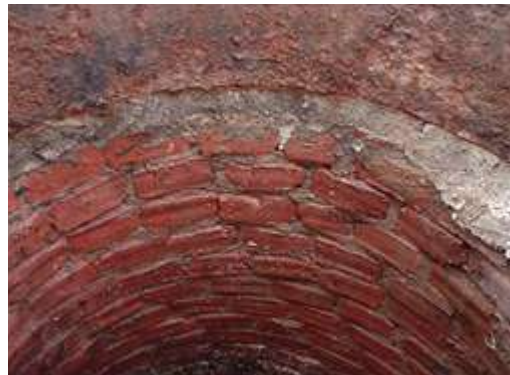
Defect 2

Infiltration: ☐ None ☐ Joint ☐ Cracks ☐ Mortar ☐ Roots ☒ **Wall**

infiltration

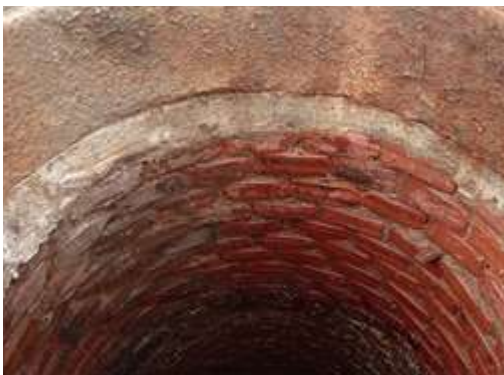
Defect 1

Steps Count: **6** Missing: **1** ☐ Corroded

Deterioration, missing step

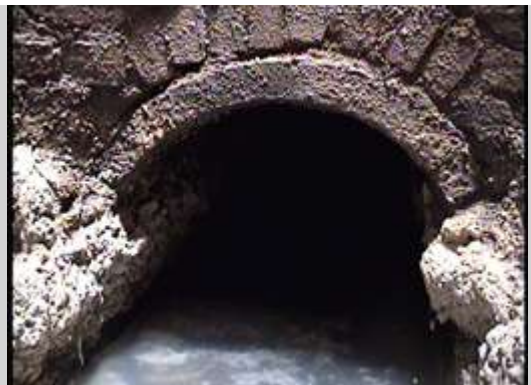
12 O'Clock Outflow

21 in. Circular Gravity Sewer
Pipe Out @ 12 O'Clock

Infiltration: **None** Pipe Seal Cond: **Sound**
